CERCLA Preliminary Assessment

**Cannell/Puri Development
Winnebago County, Rockton, IL
ILN# 000510203**

**PREPARED BY:
ILLINOIS ENVIRONMENTAL PROTECTION AGENCY
BUREAU OF LAND
DIVISION OF REMEDIATION MANAGEMENT
OFFICE OF SITE EVALUATION**

AUGUST 2007

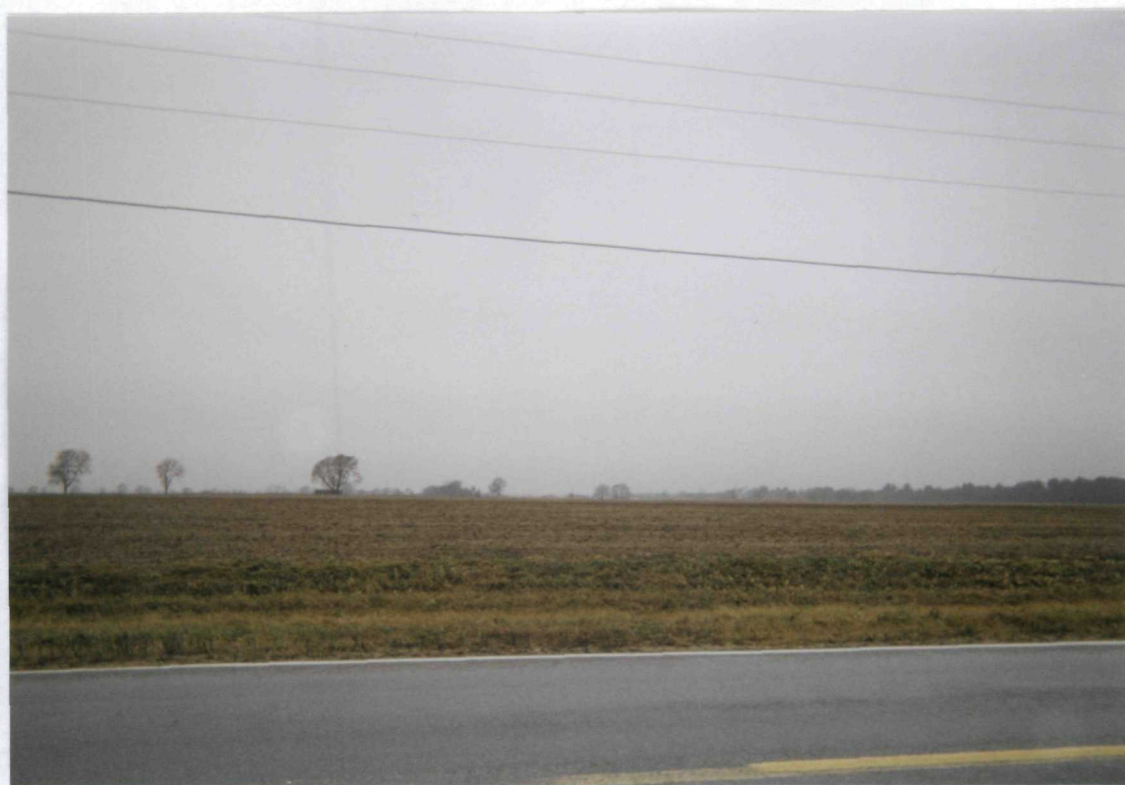
Taken from
Prairie Ave
along the eastern
boundary.
Roadside ditch
that was reported
as receiving
sludge is in the
foreground.

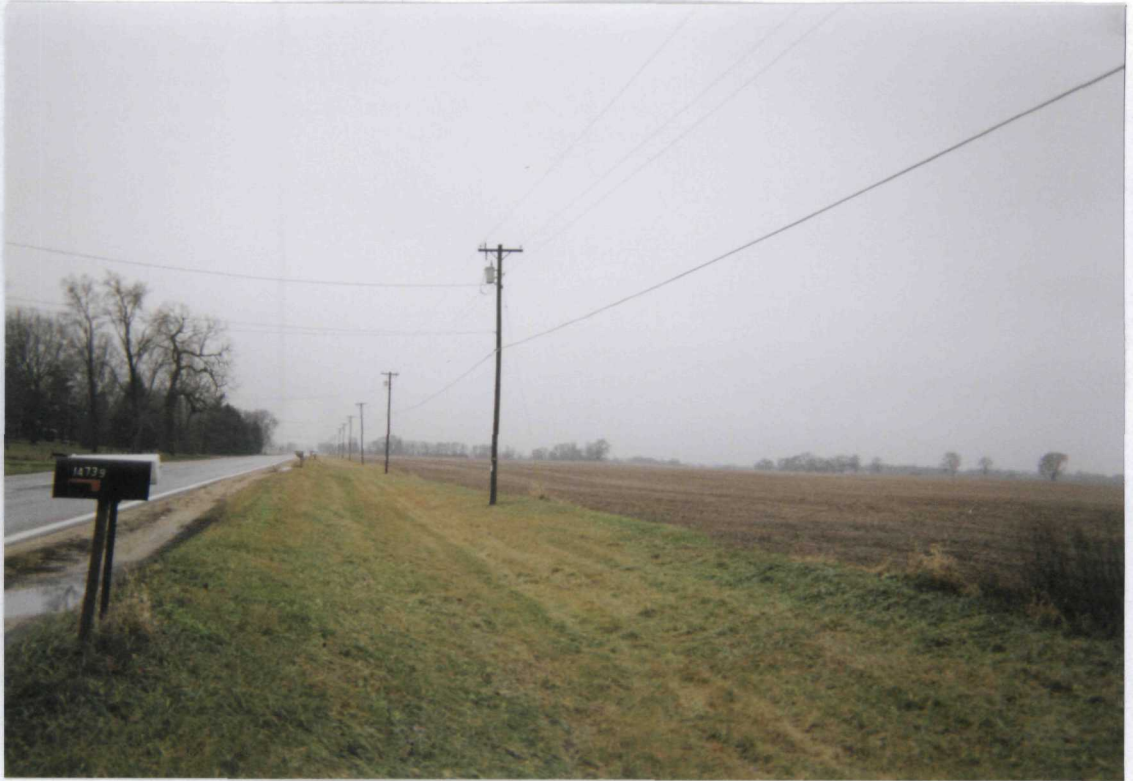
Taken from
Prairie Ave. at
the NE corner of
the property.
Picture show the
roadside that was
reported to have
received sludge
from the
property.

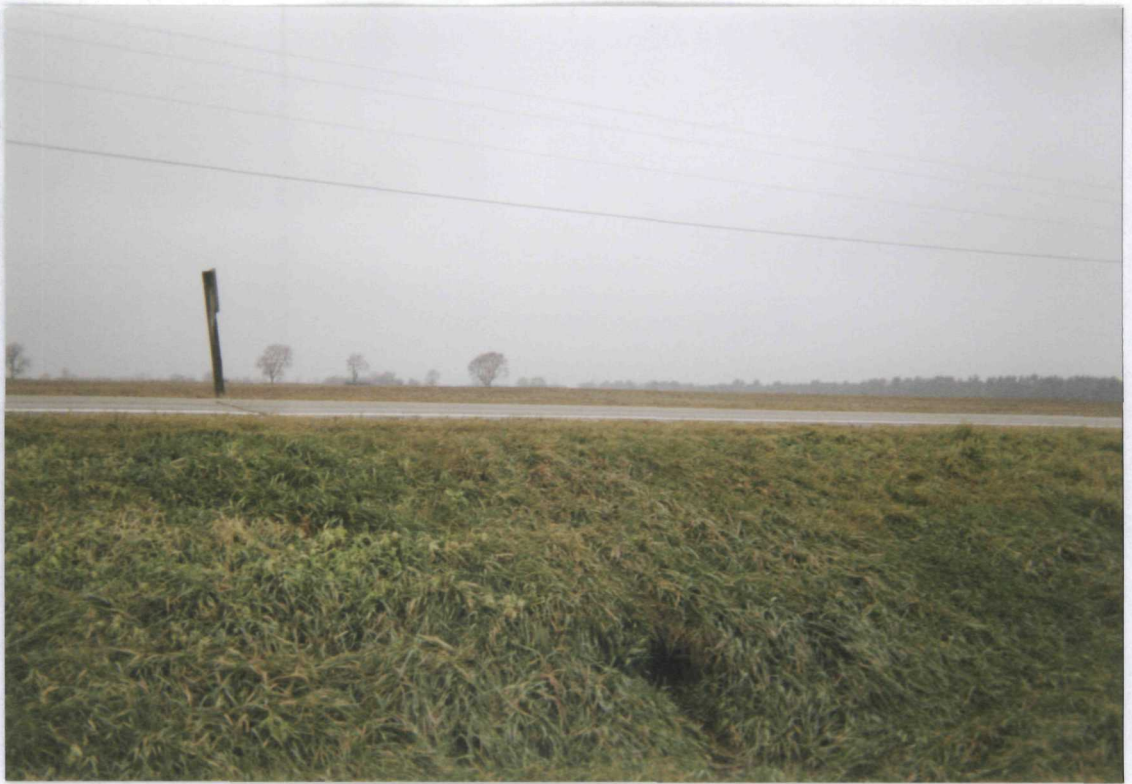
Taken from the south east corner of the property, on the eastside of Prairie Ave. The Picture shows culver that drains surface water from the site (drainage towards the SE under Prairie rd.).

Overland flow of site run-off water from the central and southern portion of the property flows east into the previously discussed ditch that runs parallel to Prairie Avenue. Unlike run-off from the northern portion of the site, run-off from the central and southern portions that enters the roadside ditch flows to the south east corner of the property where at that point it flows through a culvert under Prairie Avenue to the adjacent farm field. From that point run-off flows south for approximately 500 feet south

across a farm field and then it flows in a south western direction once again crossing under Prairie Avenue by way of a culvert. Surface water then flows 1,000-2,000 feet to the south west where it then crosses under Rockton Road and enters into a ravine that cuts through lands owned by the National Land Institute Nygren Wetlands. In an interview with a project manager at the Nygren Wetlands, the previously discussed pathway of run-off water from the site in question was corroborated. Water flows south west through the ravine south of Rockton Road for approximately 1,000 feet to the probable point of entry (PPE) where it meets the Nygren wetlands. The Nygren wetlands are contiguous to the Pecatonica River.

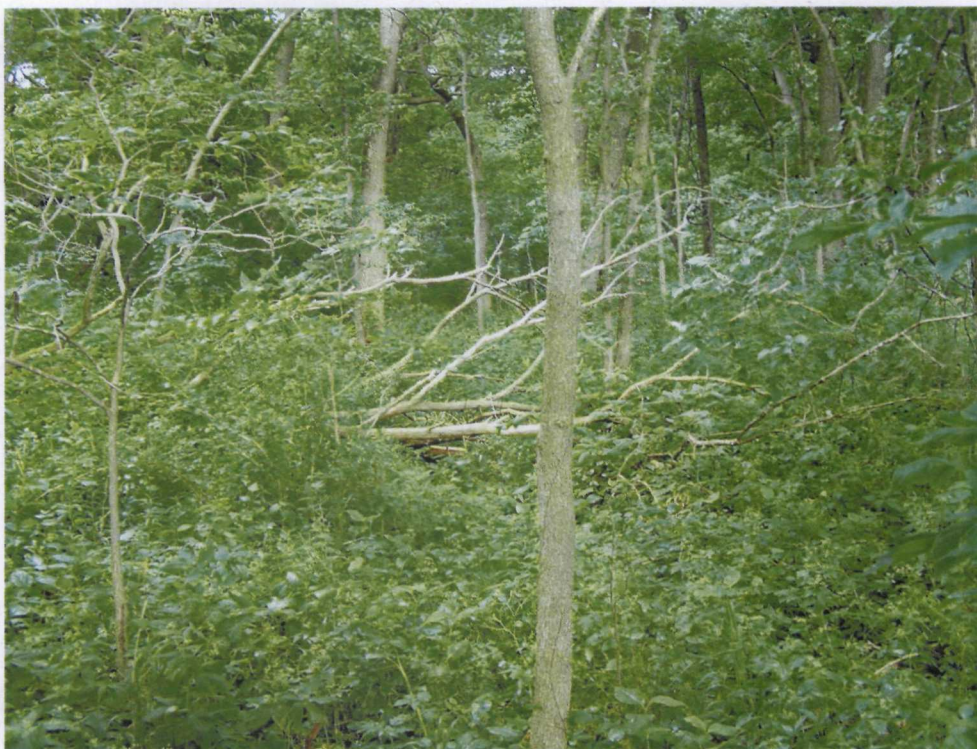
Adjacent to the PPE.
Ravine that carries run-off water to the PPE at the Nygren Wetlands

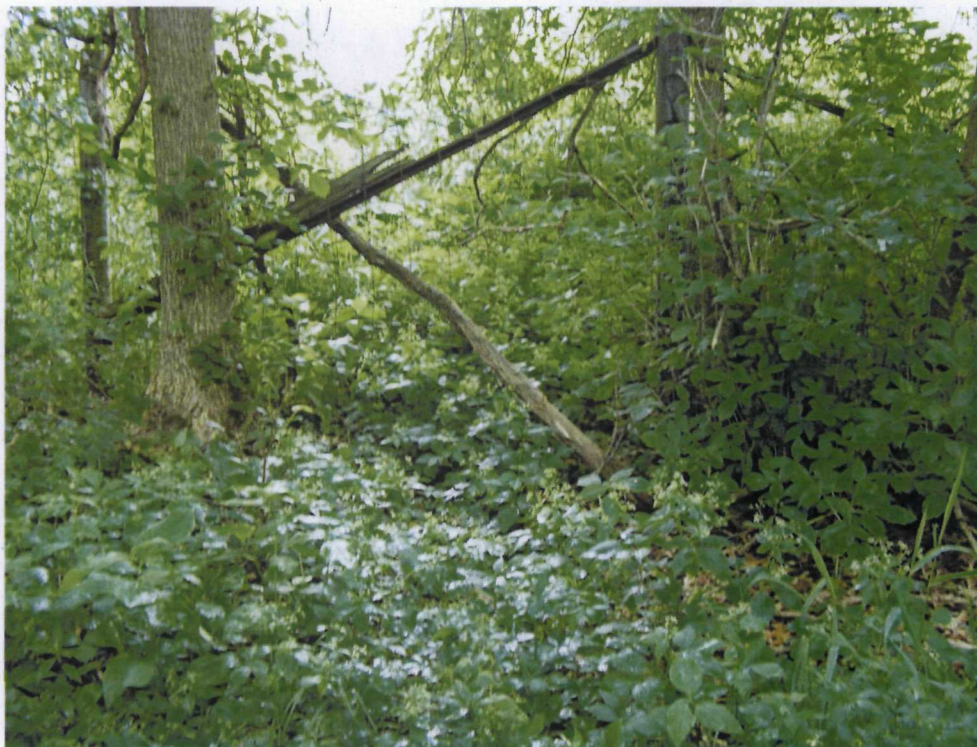
Adjacent to the PPE.
Run-off flows under fence and out into the Nygren Wetlands on the other side of the fence.

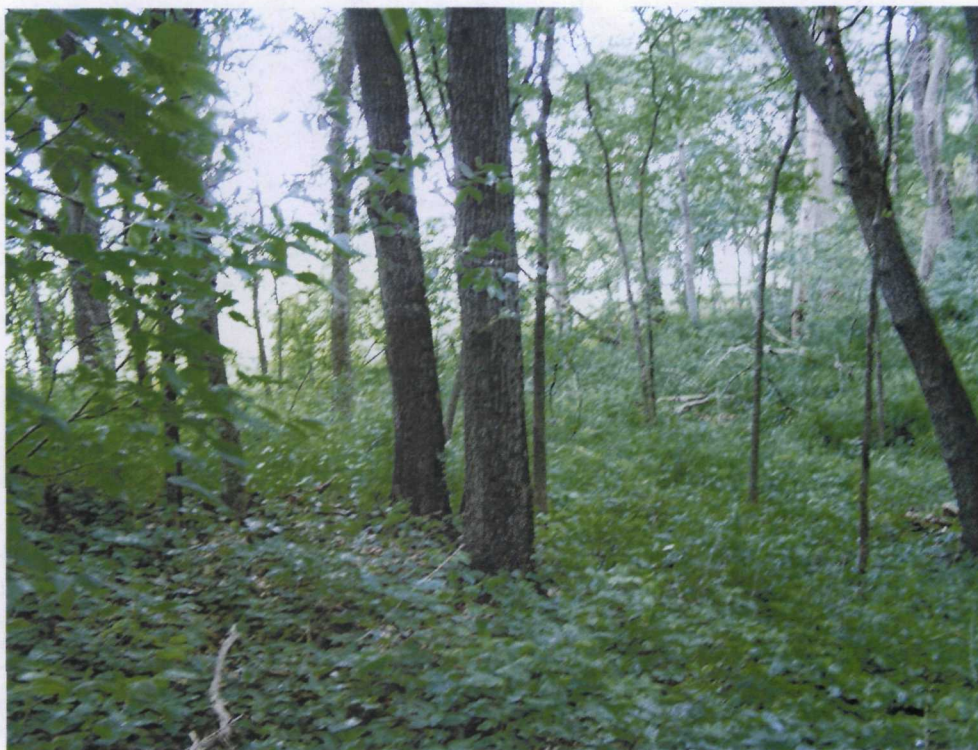
DATE: : 6-6-07
TIME: 16:30
PHOTO BY: Wes King
DIRECTION: SW
COMMENTS: 50 feet NE of the PPE. Ravine that carries run-off water to the PPE. Clear area in background is the Nygren Wetlands.

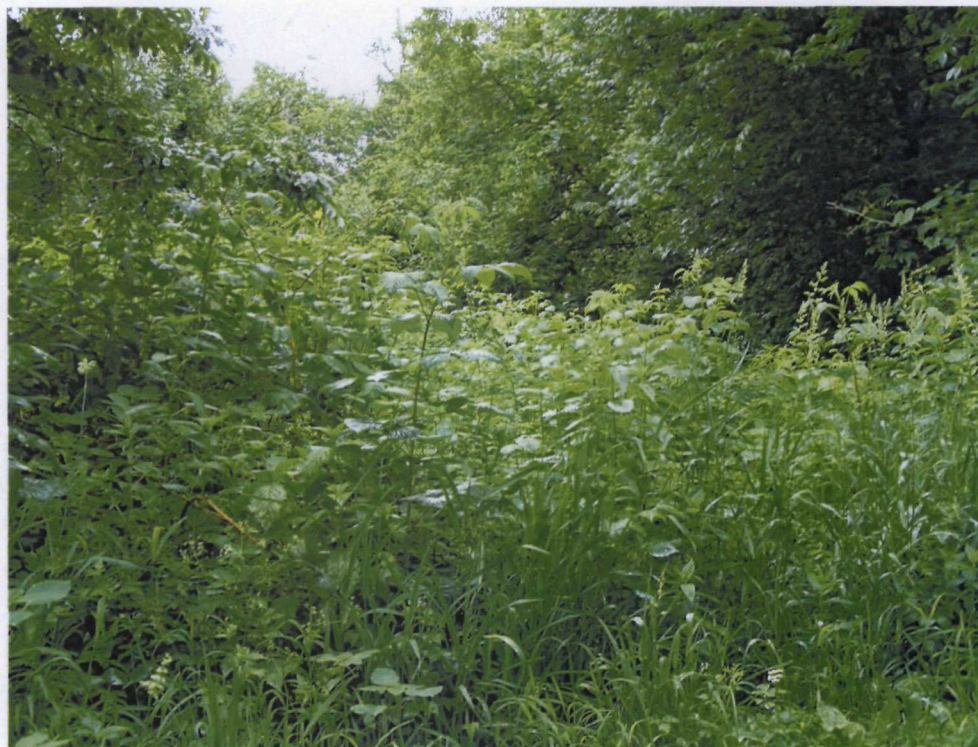
DATE: : 6-6-07
TIME: 16:45
PHOTO BY: Wes King
DIRECTION: SW
COMMENTS: 20 feet south of Rockton rd. The beginning of the ravine that carries run-off water to the PPE
